HIGH TEMPERATURE STRENGTH CHARACTERIZATION OF SINTERED
ALPHA SILICON CARBIDE(U) FORD MOTOR CO DEARBORN MI
CERAMIC MATERIALS DEPT R K GOVILA OCT 82

High Temperature Strength Characterization of Sintered Alpha Silicon Carbide

REPORT FOR THE PERIOD
April 1, 1980 - December 31, 1981

R. K. Govila
Ceramic Materials Department
Scientific Research Staff
Ford Motor Company
Dearborn, Michigan

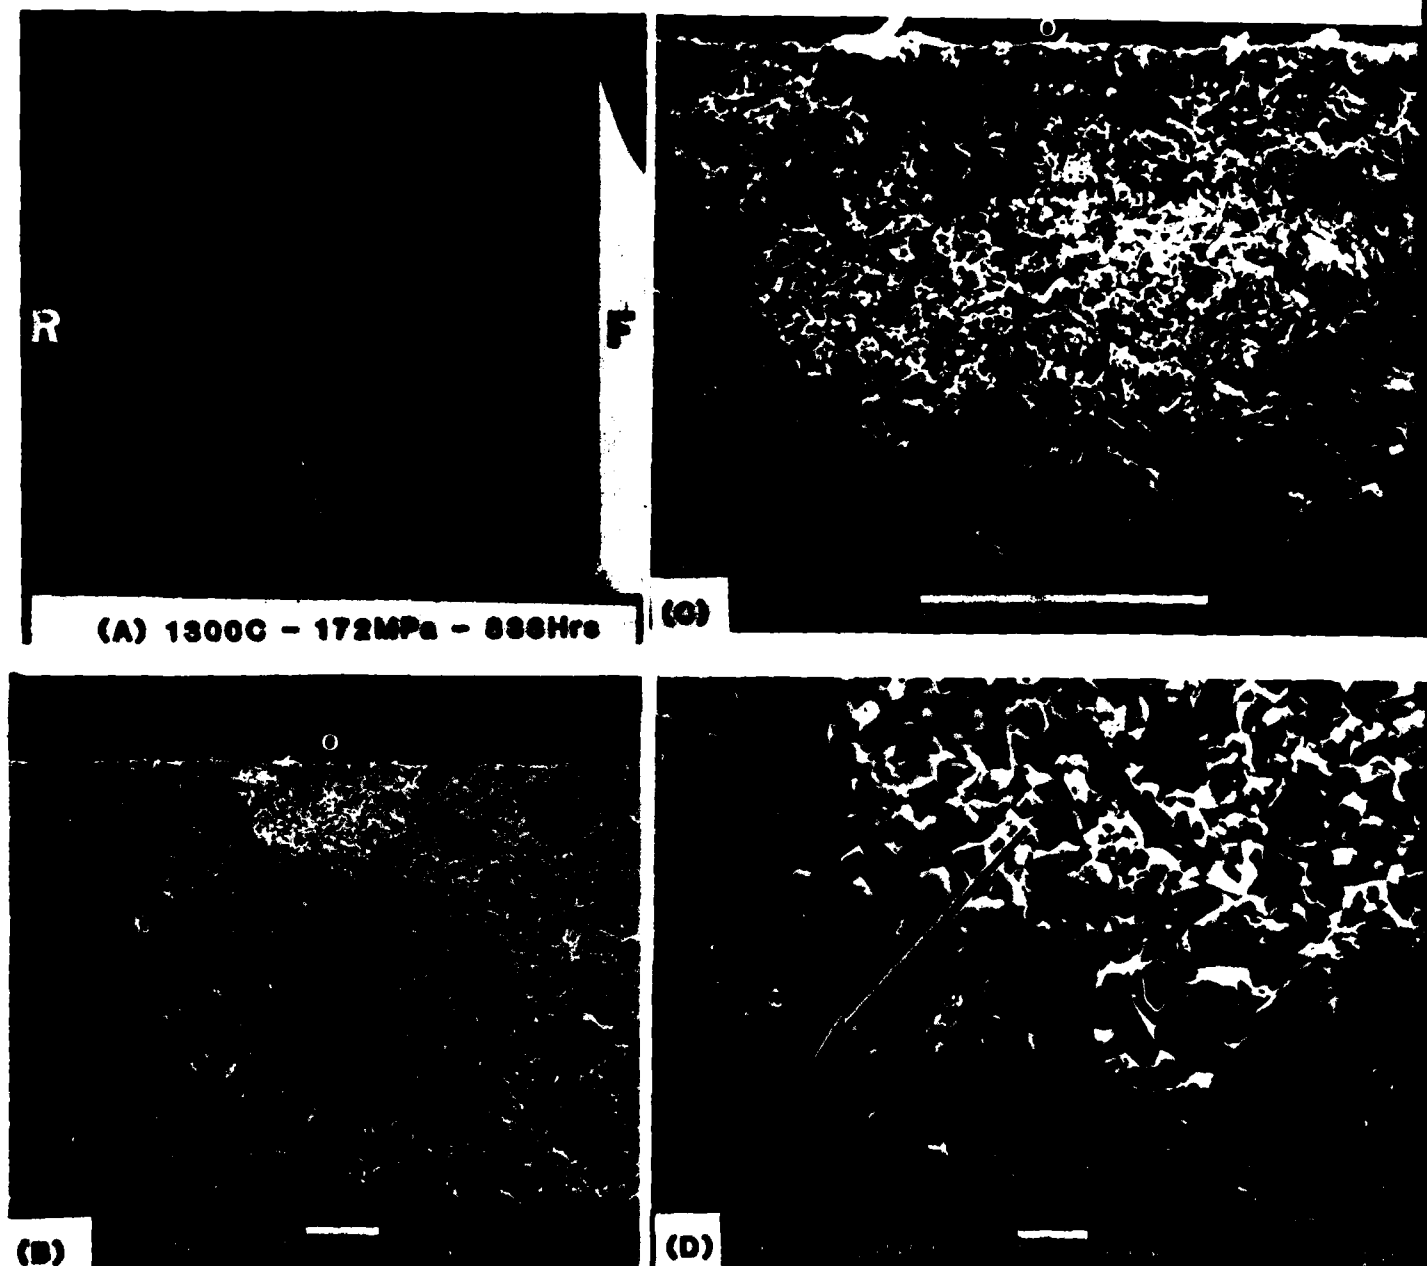
Fig. 29 SEM micrographs of the fracture surface of specimen #10 tested at 1300°C in air at 172 MPa and failed after 833 hrs. (A) Surface associated failure site. (B) ACB is the failure site and represents the slow crack growth region. (C) Higher magnification view of the SCG region ACB. (D) Arrow indicates the transition from slow crack growth (SCG) region to fast failure region. Note, the nature of crack propagation inside the SCG region is primarily intergranular while outside the SCG region, it is transgranular failure.

(#10) was tested at the same stress (172 MPa) and temperature and failed after 833 hrs. The fracture face showed clearly the failure site, followed by a mirror region, Fig. 29(A). The failure site consisted of a semi-circular region ACB, Fig. 29(B), which was actually a SCG region, Fig. 29(C). Once the crack (flaw) grew to a critical size, catastrophic failure occurred. The nature of crack propagation during SCG is intergranular while the fast fracture occurred by transgranular mode as seen clearly in Fig. 29(D). Arrow (Fig. 29(D)) indicates the transition from SCG to fast fracture. Inside the SCG region, separation of grains characteristic of intergranular crack propagation is clearly visible. No large voids similar to the one observed in Specimen #9, Fig. 28, were observed in the SCG region. Fine porosity was visible. The strong dependence of SCG on temperature should be noted. Specimen (#2, #3) tested at 1200°C and 172 MPa (25,000 psi) did not show the presence of SCG, even though the specimen failed after 1900 hrs. (#2).

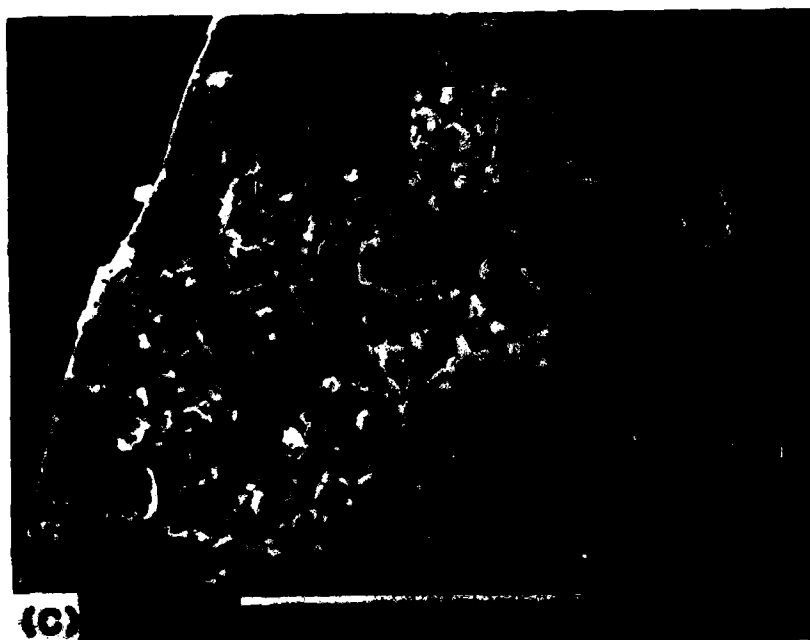
Figure 32

SEM micrographs of the fracture surface showing failure initiation site and the associated slow crack growth region.

and fast failure. It is equally probable that the early failure in this specimen was primarily due to localized porosity inside the failure region and under stress, the pores got interconnected and acted as a single large flaw (crack); thus producing fast fracture. Inside the failure zone, Fig. 33(C), the absence of SCG is clearly visible (cf. Fig. 33(C) and Fig. 32(C)) and the fracture face has the appearance of transgranular failure.

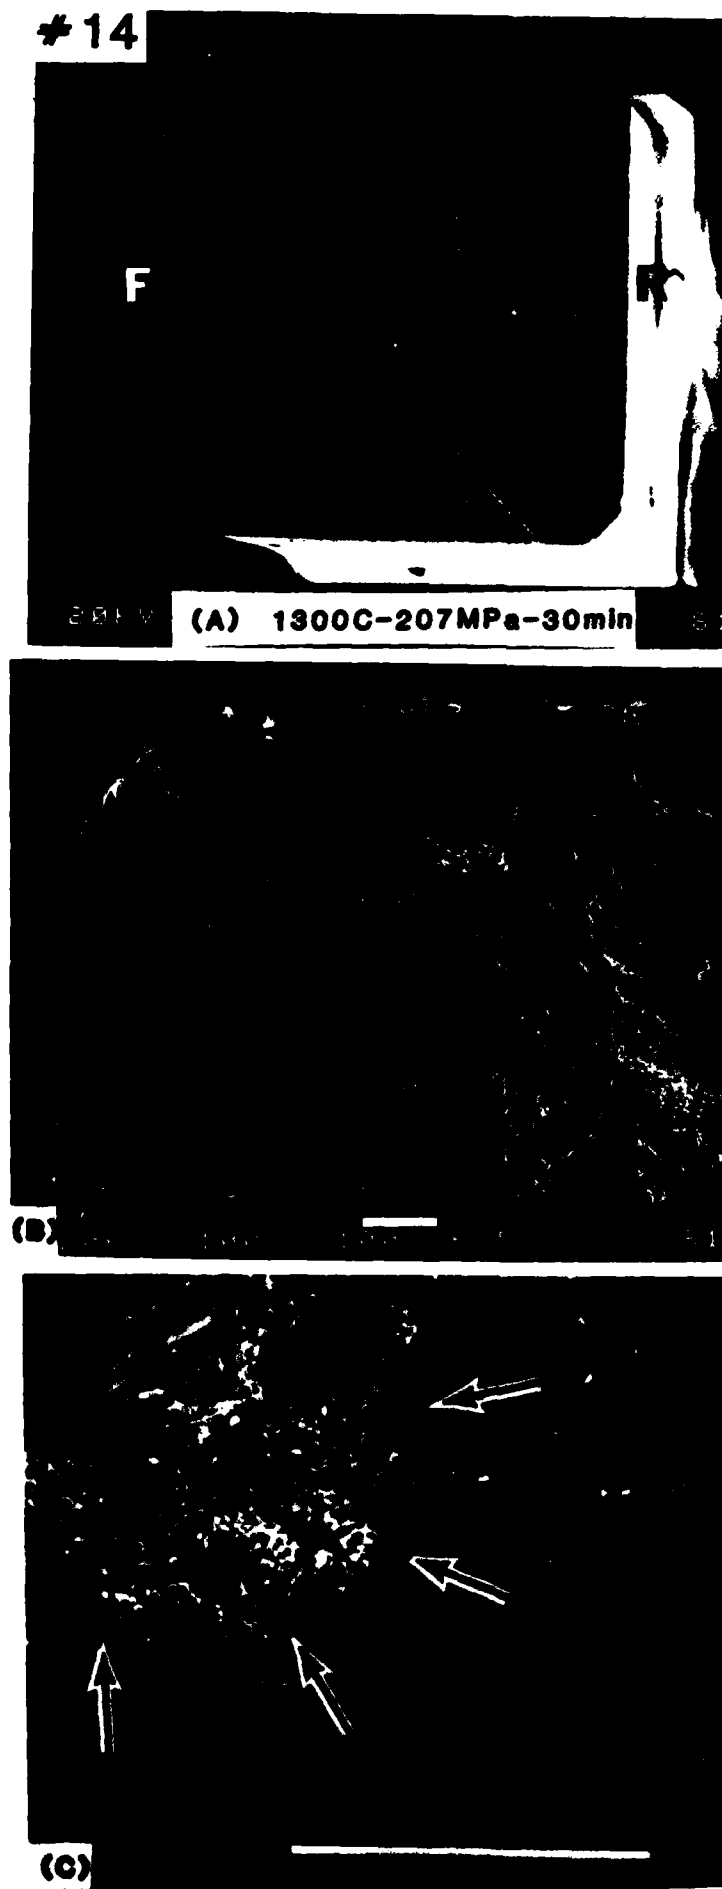
Figure 33

SEM micrographs of the fracture surface showing possible machining damage leading to fast failure.

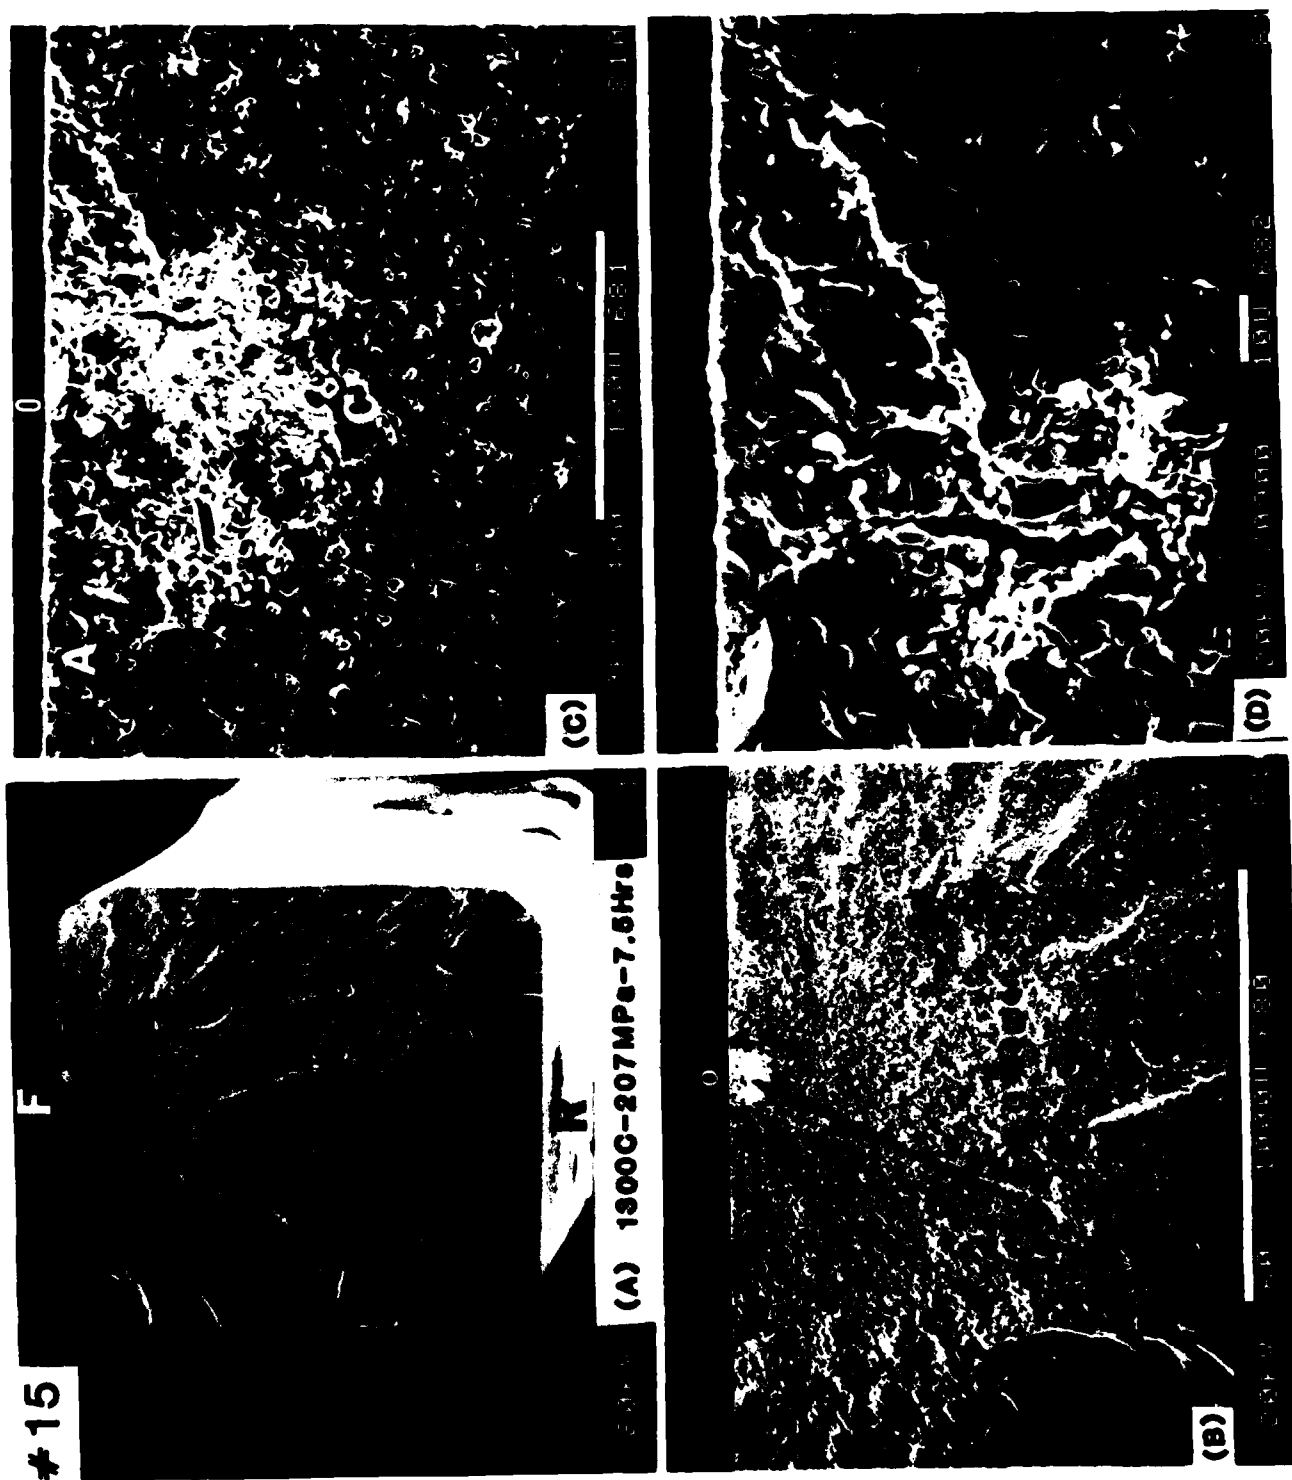
Fig. 34 SEM micrographs of the fracture surface showing the surface associated slow crack growth (SCG) region, separation of grains inside the SCG region and porosity.

The specimen #15 which failed after 7.5 hrs. showed a large failure initiation site in the front face, Fig. 34(A). The failure site consisted of a large SCG area designated ACB followed by a mirror region, Fig. 34(B). Separation along the grain boundaries was clearly visible, inside the ACB region, Fig. 34(C). Outside the SCG region, the crack propagation mode is transgranular, Fig. 34(D), while inside it is intergranular.

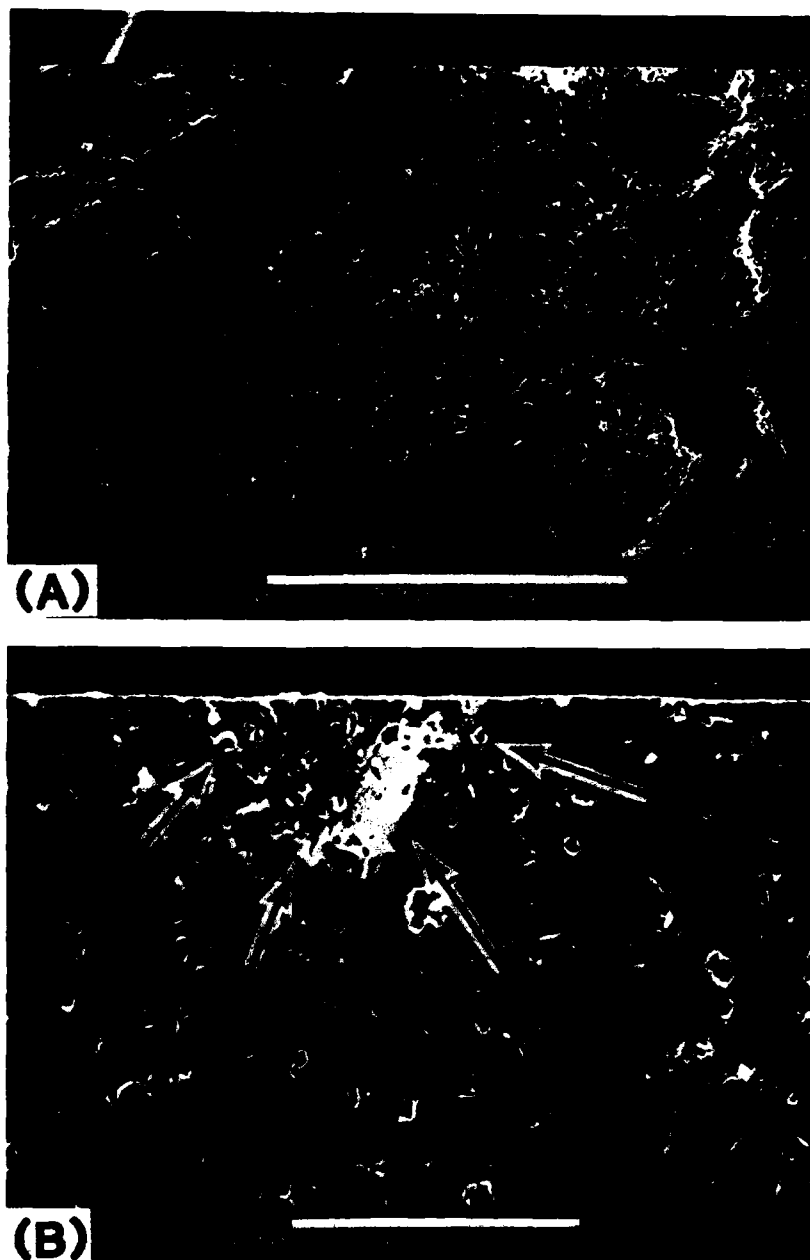
Fig. 36 SEM micrographs of the fracture surface of a specimen tested in 4-pt. bending showing the failure site. Note the presence of a large single α -SiC grain. No visible SCG.

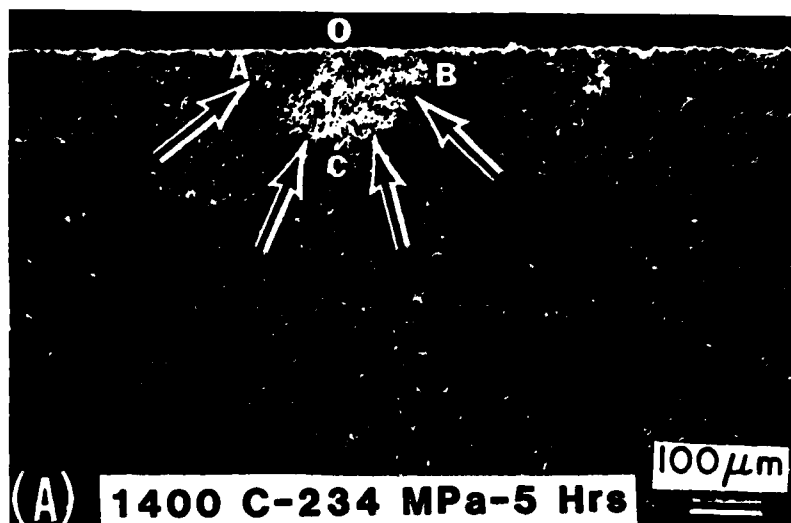
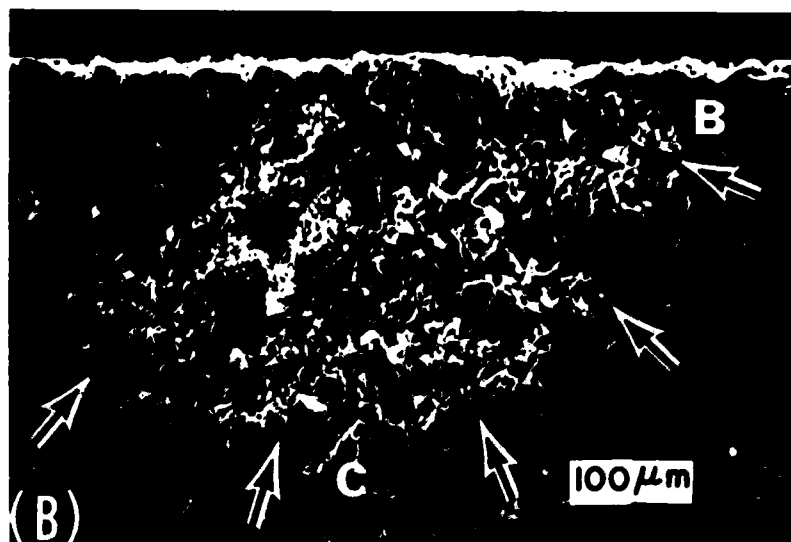
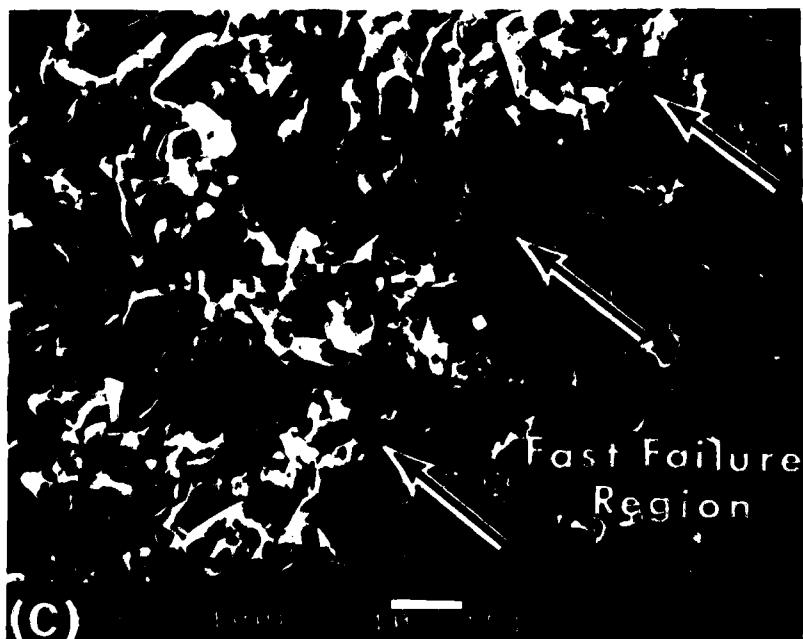
Figure 38

SEM micrographs of the fracture surface of a specimen tested in 4-pt. bending at 1400°C in air at 234 MPa and failed in 300 mins. (A) ACB is the slow crack growth region. (B) Higher magnification view showing porosity associated with SCG region. (C) Higher magnification view along the crack front (SCG region) boundary BC. Arrows separate the transition from slow crack growth to fast fracture region. Note the crack propagation in the SCG region is primarily intergranular while in the fast failure region it is transgranular.

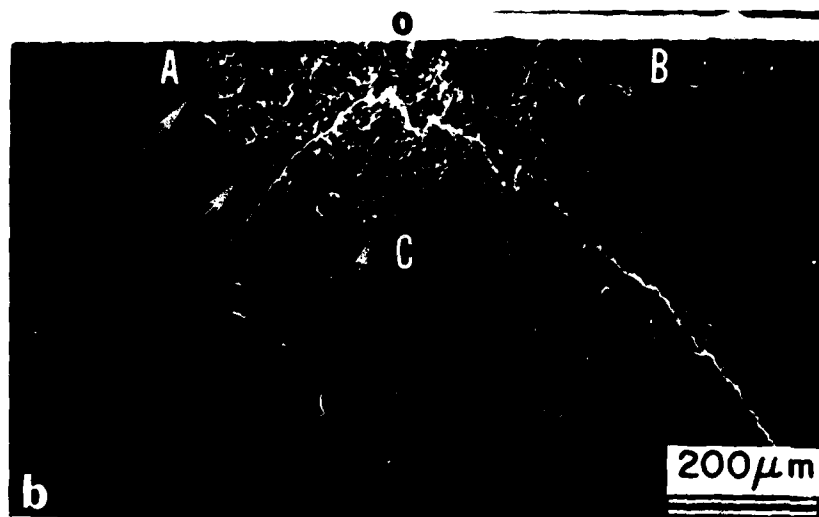
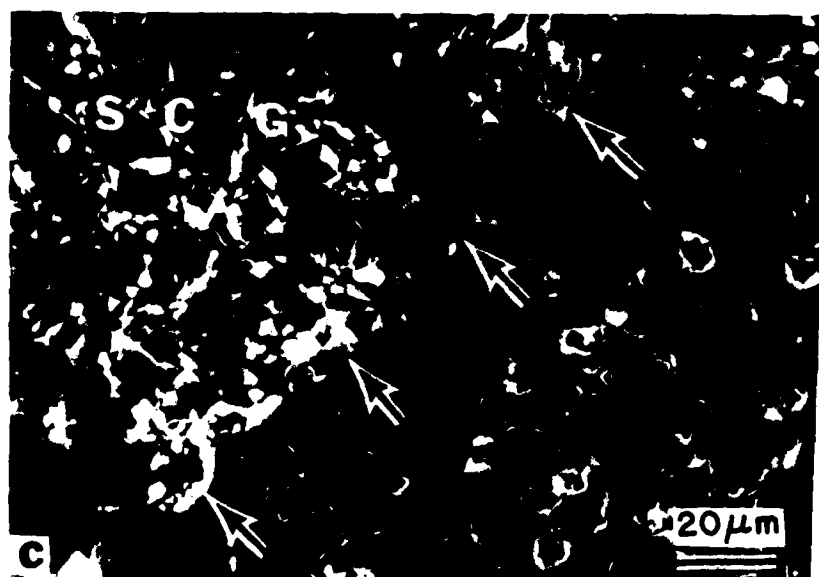
Figure 39

SEM micrograph of the fracture surface of a stress rupture specimen tested in 4-pt. bending. (a) Failure initiation site. (b) ACB is the slow crack growth region. Note the change in morphology of the fracture surface outside the slow crack growth region. (c) Circled area in (b) shown at a higher magnification. Arrows indicate the end of SCG region and start of the fast fracture region.

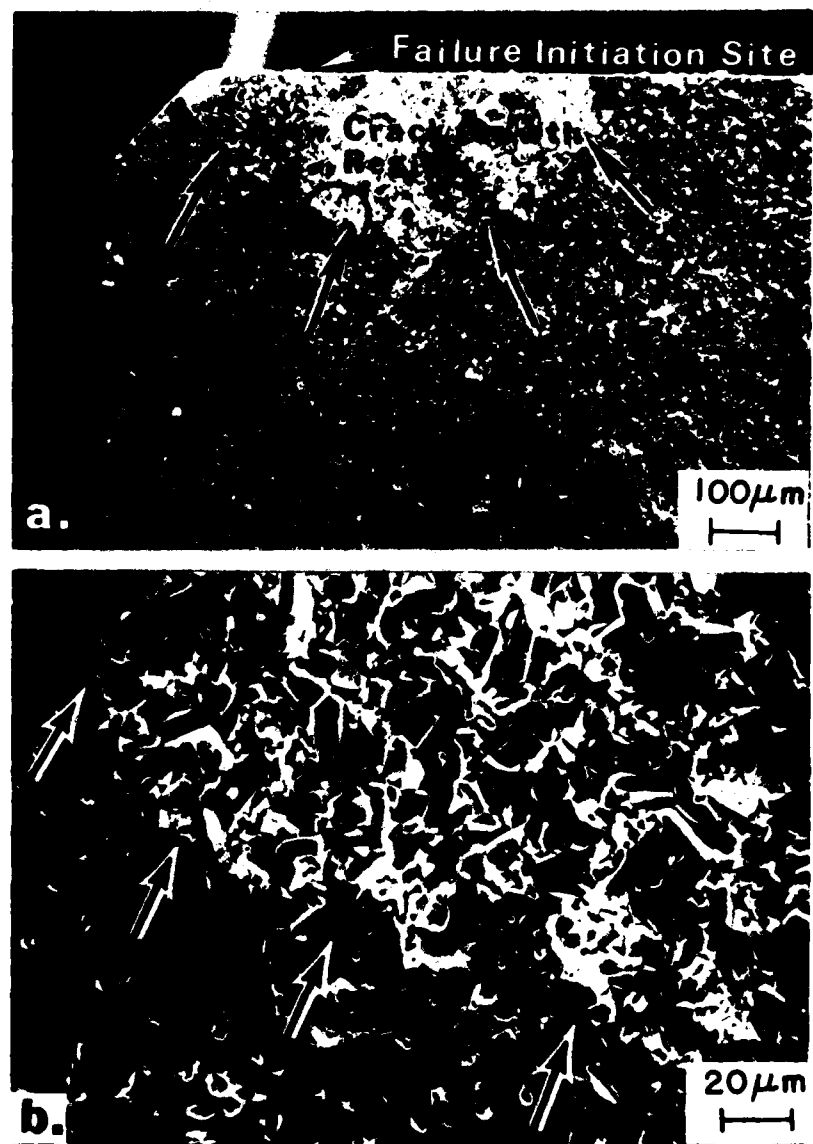
Fig. 40 SEM micrographs of the fracture surface of a stress rupture specimen tested in 4-pt. bending. (a) Failure initiation site and the associated slow crack growth region, ACB. (b) Circled area in (a) seen at a higher magnification. Arrows indicate the boundary of the SCG region.

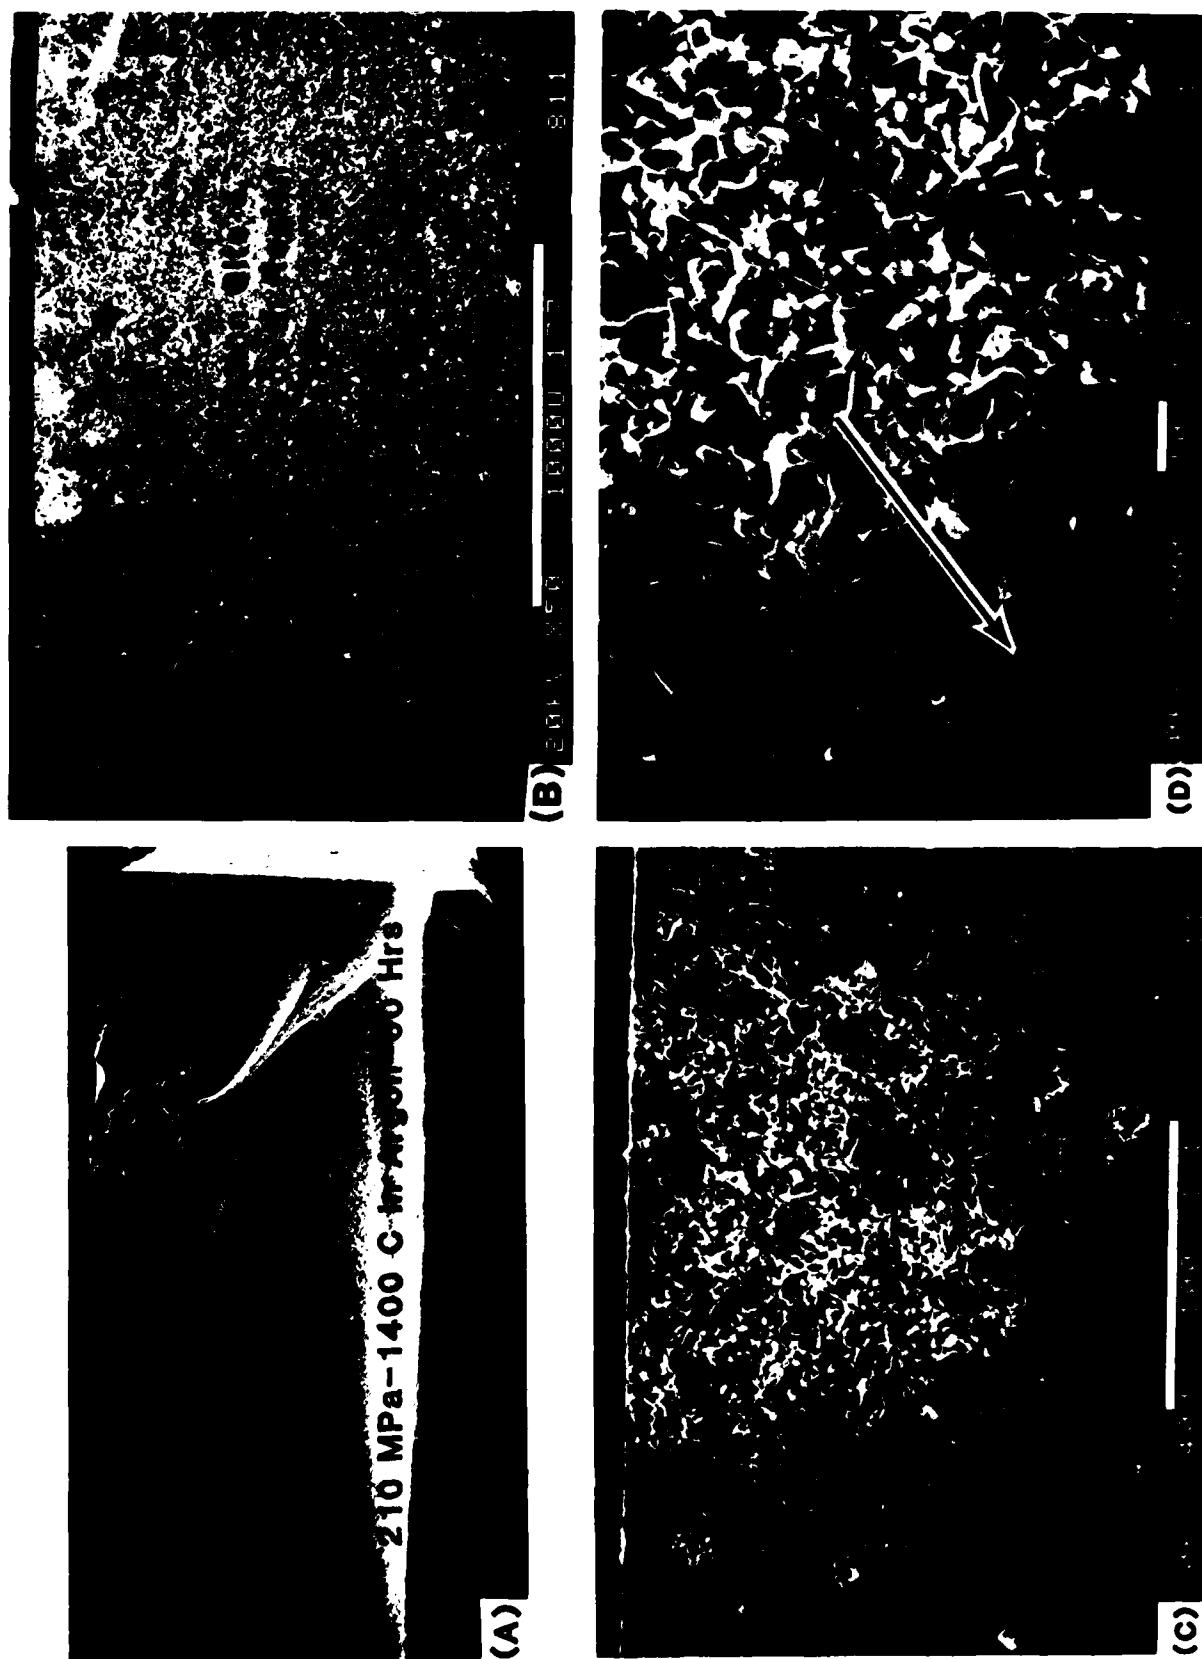
Fig. 41 SEM micrographs of the fracture surface of a flexural stress rupture specimen tested at 1400°C in partial Argon gas environment. (A) Overall view of the fracture surface. (B) Failure initiation site and the associated slow crack growth region. (C) Higher magnification view of the SCG region. (D) Arrow indicates the transition from slow crack growth to fast fracture. Note the separation of grains inside the SCG region indicating intergranular crack propagation while transgranular crack propagation outside it (in the fast fracture region).

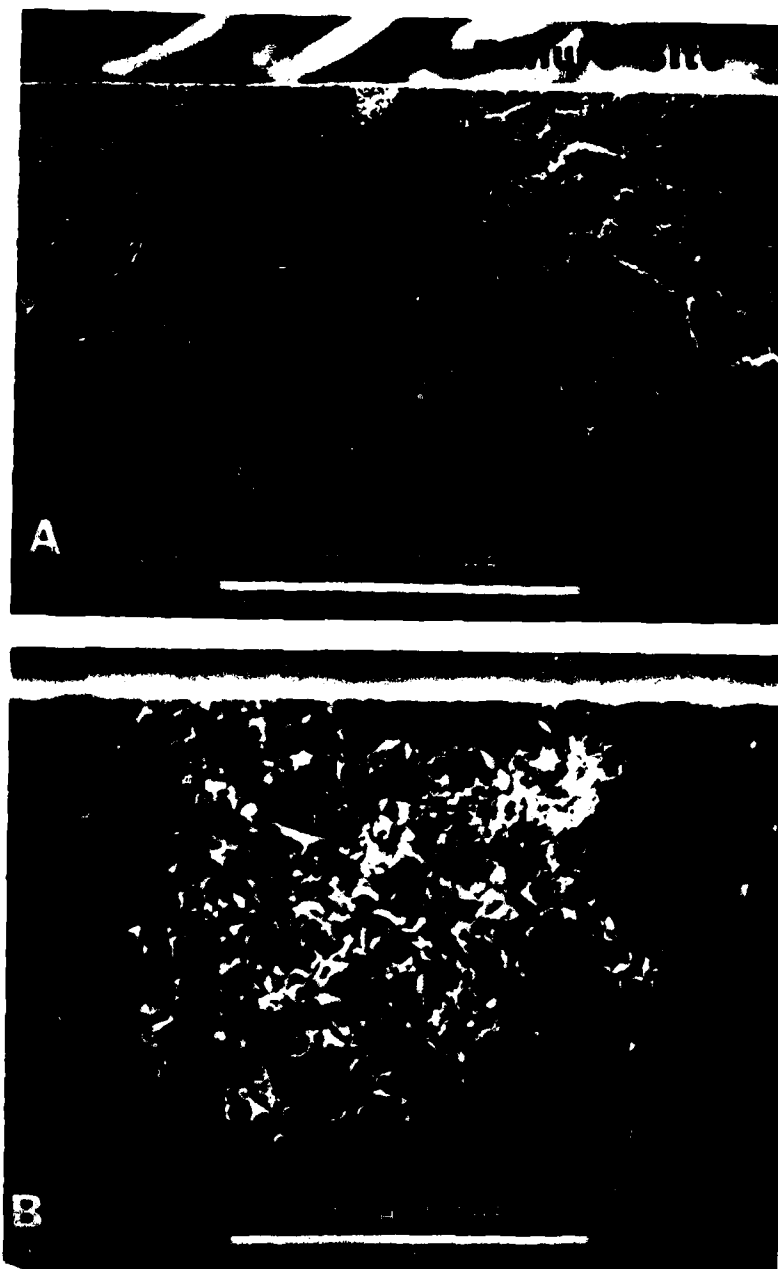
Fig. 42 SEM micrographs of the fracture surface of a flexural stress rupture specimen tested at 1300°C in air. (A) Failure initiation site (B) Porosity and the associated slow crack growth region.

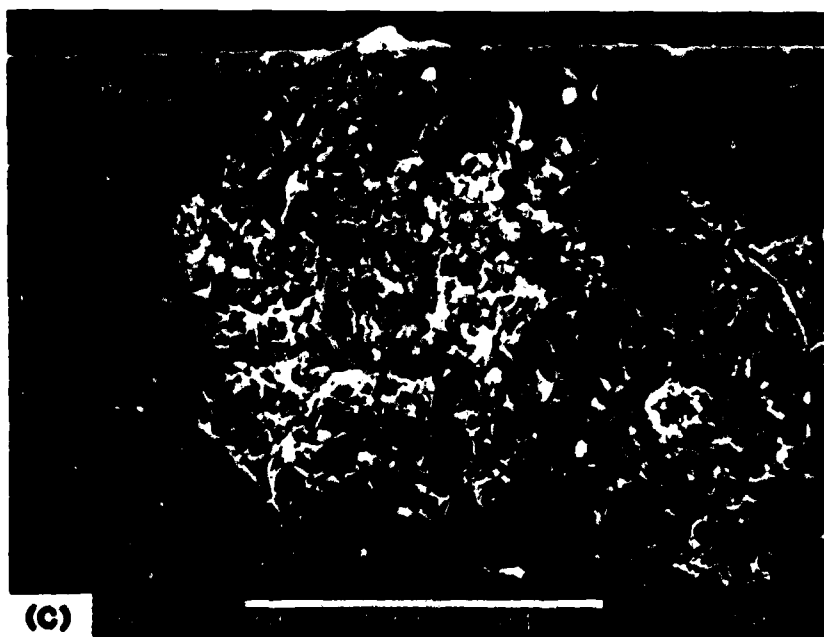
Figure 43

SEM micrographs of the fracture surface of a flexural stress rupture specimen. (A) Overall view of the fracture surface. (B) Failure origin ACB is the slow crack growth region. (C) Higher magnification view of the slow crack growth region. Note the grain boundary openings.

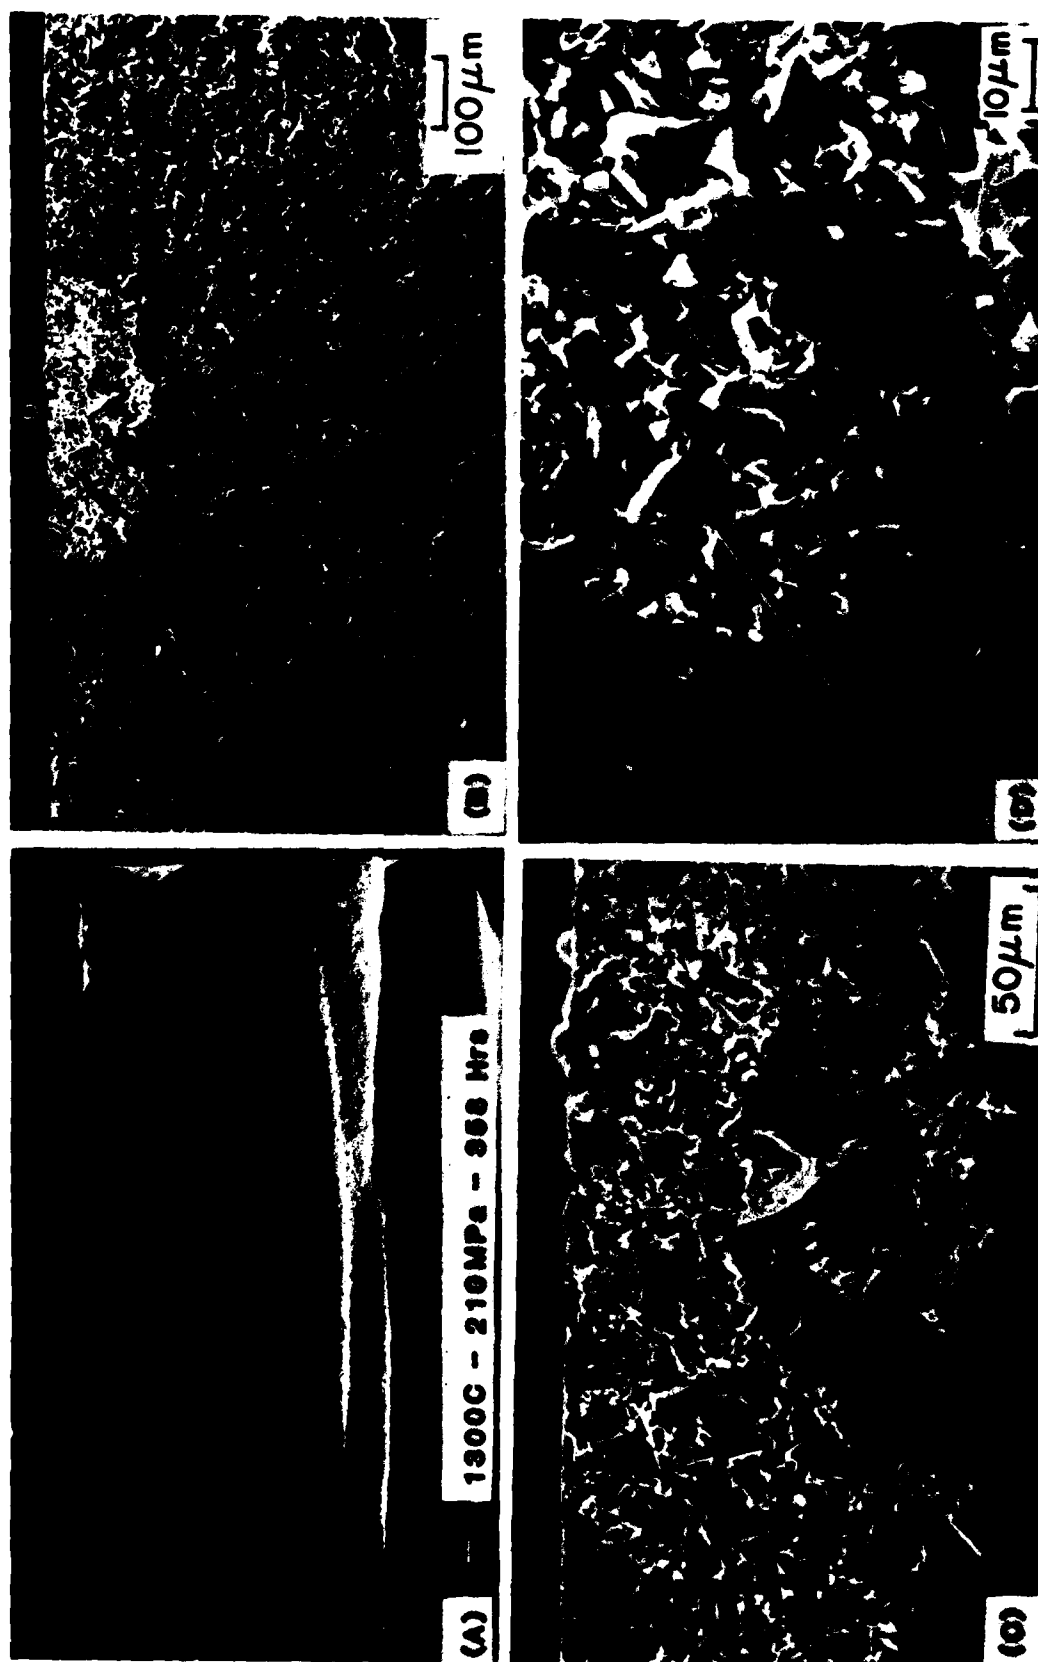
Fig- 44 SEM micrographs of the fracture surface of a flexural stress rupture specimen.
 (A) Overall view of the fracture surface (B). ACB is the slow crack growth region.
 (C) Higher magnification view of the SCG region. (D) Arrow indicates the transition from SCG region to fast fracture.

The applied stress was further decreased to 210 MPa (30,500 psi) and the specimen sustained the stress for a significantly longer time, failing after 358 hrs. Fracture face showed a large SCG region, Fig. 44, associated with surface similar to that seen earlier.

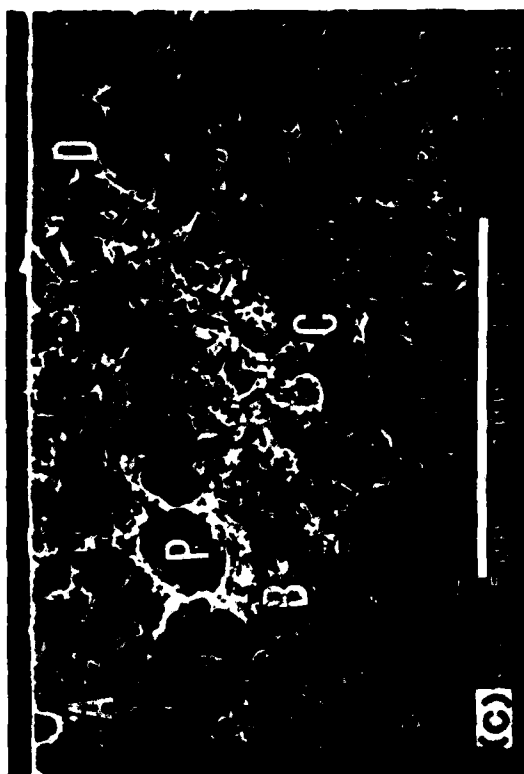
Fig. 45 SEM micrographs of the fracture surface of a flexural stress rupture specimen tested at 1300°C in partial Argon gas environment. (A) Overall view of the fracture surface (B) Failure Initiation Region (C) Higher magnification view of the failure site showing that ABCD is the slow crack growth region. Note large porosity (P) inside the SCG region. (D) Arrow indicates the transition for slow crack growth to fast fracture.

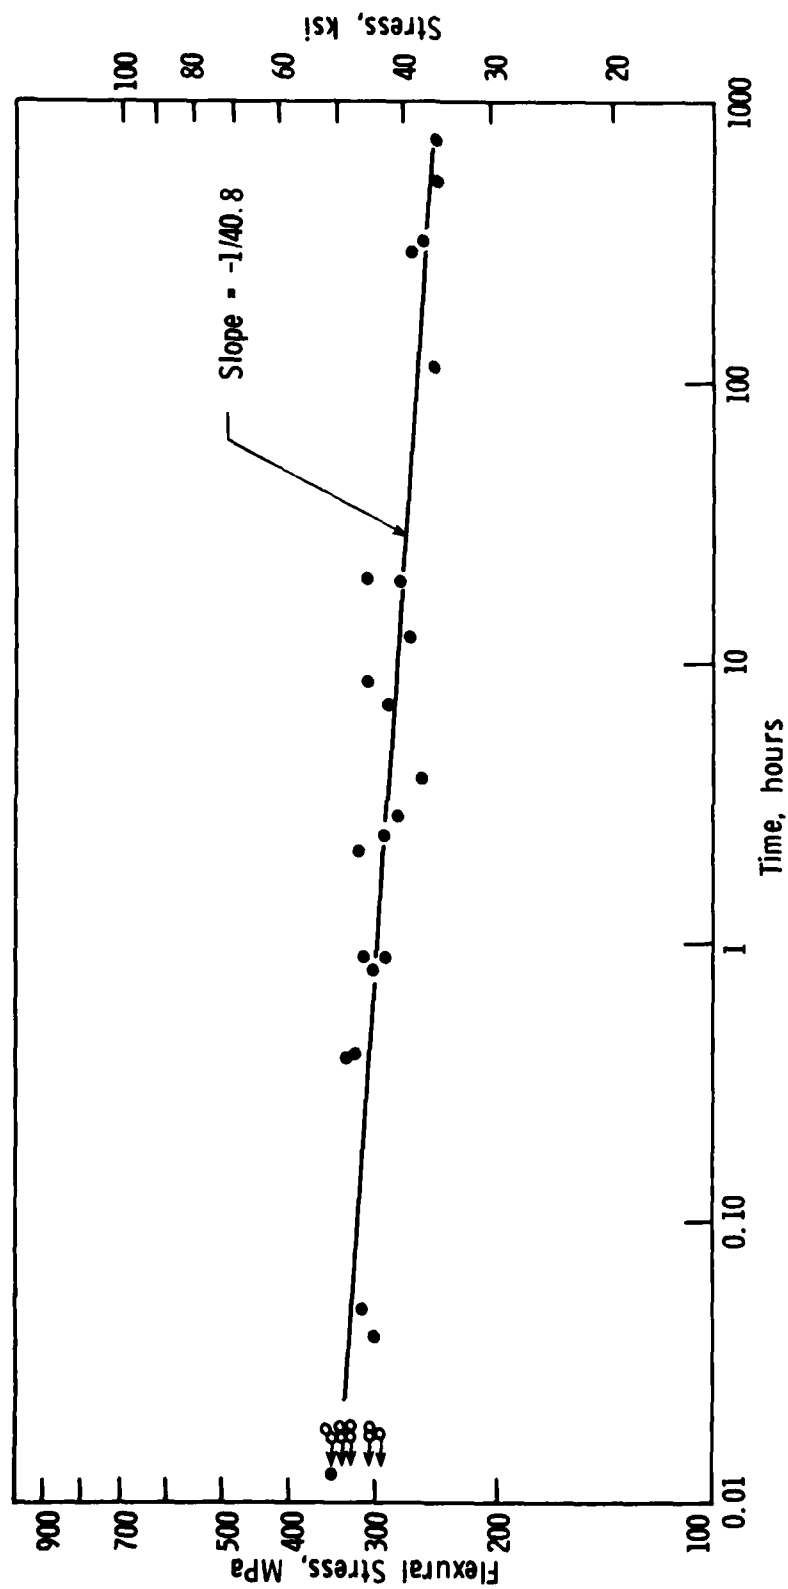
Fig. 47 Flexural stress rupture at 1200°C for Carborundum sintered alpha SiC (1978).
Courtesy of G. Quinn, AMMRC.

Flexural stress rupture studies have been made in detail by Quinn^{1,2,9} on two versions of α -SiC (1978 and 1980, sintered α -SiC from Carborundum Co.) at 1200°C in air and as such no efforts were made to carry out similar studies. Quinn has been kind enough to supply this data for inclusion in this report.

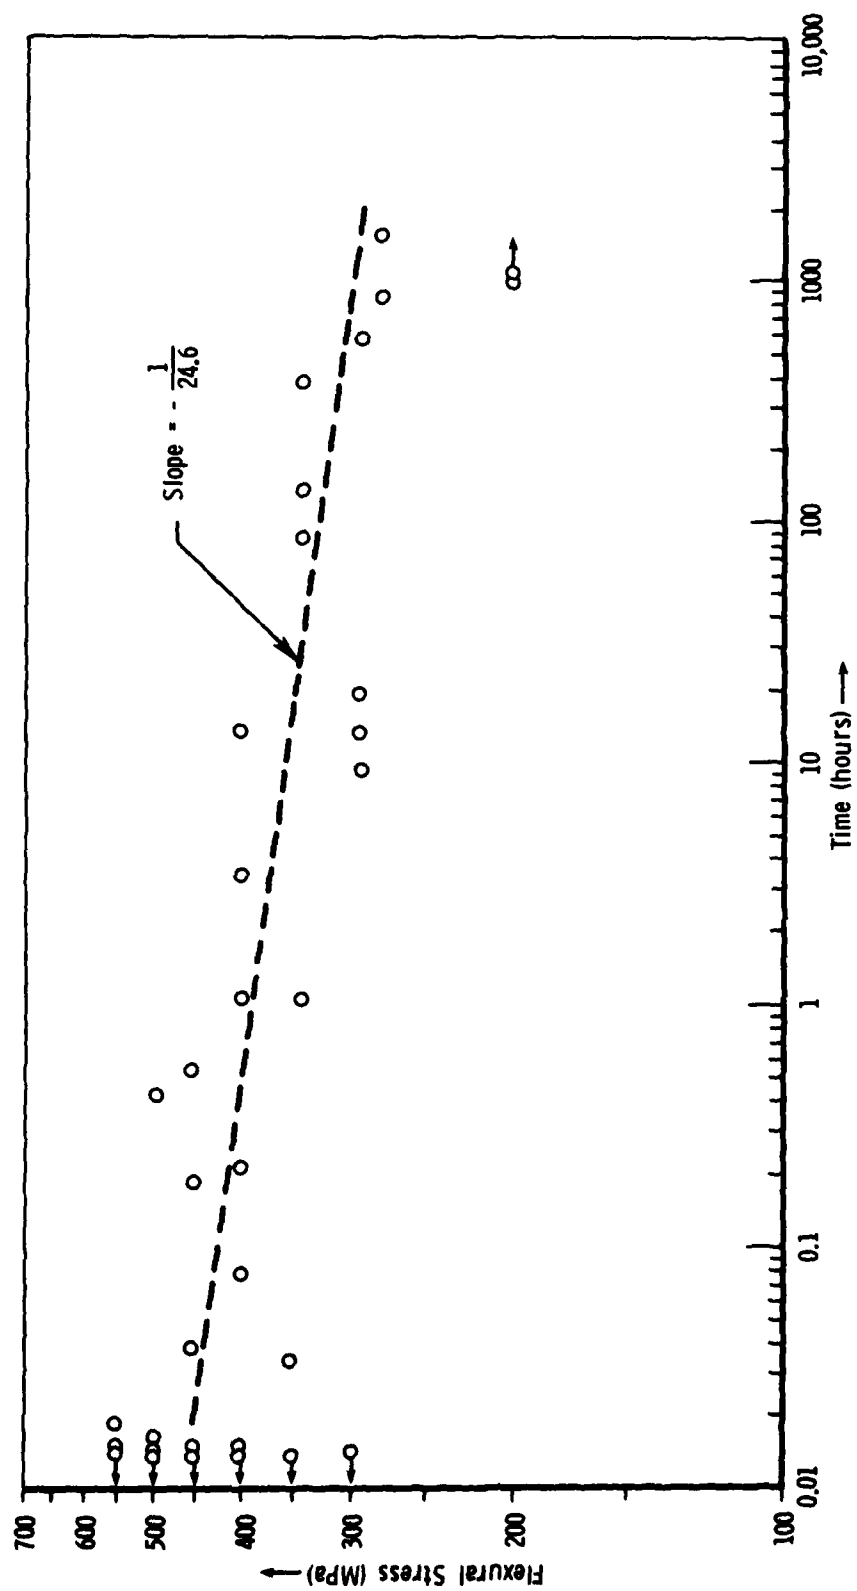
Fig. 48 Flexural stress rupture at 1200°C for Carborundum sintered alpha SiC (1980).
Courtesy of G. Quinn, AMMRC.

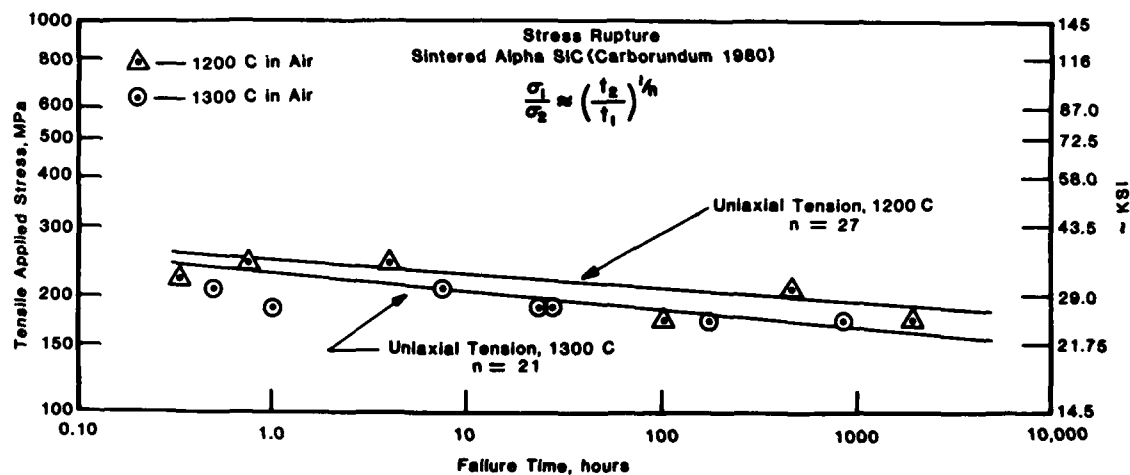
Fig. 49 Uniaxial tensile stress rupture results.

A plot of $\log \sigma$ vs $\log t$ would result in a straight line with a slope of $1/n$. The results for uniaxial tensile stress rupture testing of sintered α -SiC at 1200°C and 1300°C are shown in Fig. 49. Because of scatter and limited experimental data points, no least-squares analysis was done for curve fitting. At 1200°C and 1300°C, the values of n obtained from the plot (Fig. 49) were about 27 and 21,

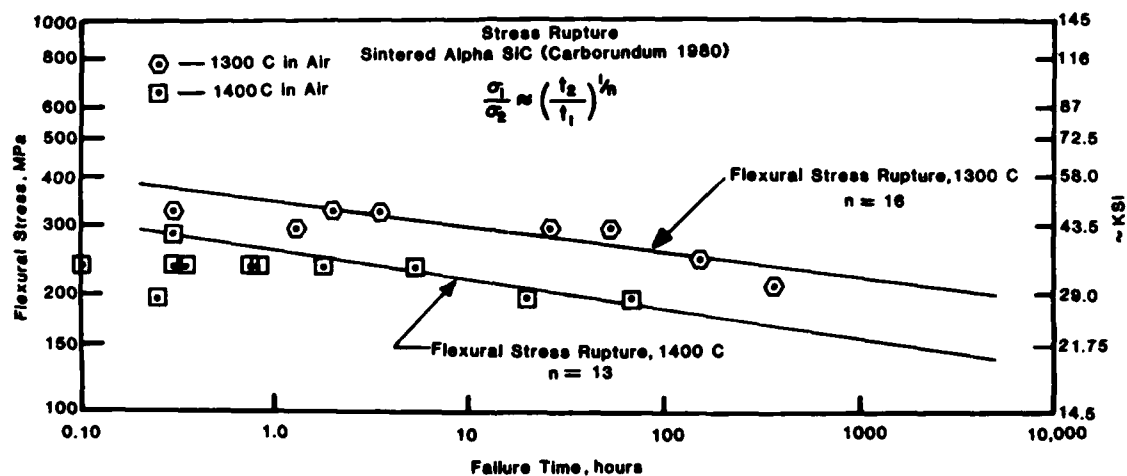
Fig. 50 Flexural stress rupture results.
